REPORT / RECOMMENDATION

Subject: Traffic Safety Committee Reports of June 3 and July 1, 2015

Traffic Safety Report

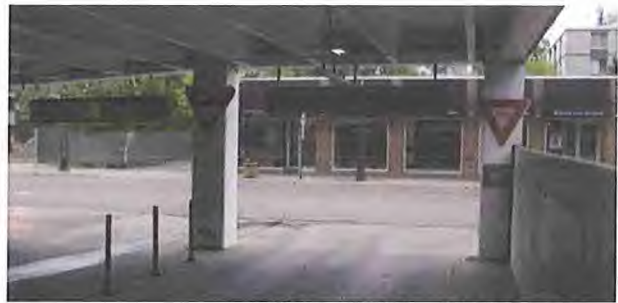
This request comes from a resident who noted that the middle ramp in the 50th and France district has a yield sign located at its exit, however this is inconsistent with state statute 169.31. This statute states that "The driver of a vehicle within a business or residence district emerging from an alley, driveway, or building shall stop such vehicle immediately prior to driving onto a sidewalk or into the sidewalk are and shall yield the right-of-way to any pedestrian and all other traffic on the sidewalk." All other city-owned parking structures and lots have stop signs at their exit, but other driveways in the area have no control at their exit. No other yield signs were observed in the district's driveways.

Photo : Exit from the Center Ramp

After review, staff recommends approving this item, and signing the exit with a Stop sign. This is done for consistency with other city owned parking areas, as well as compliance with the Minnesota State Statute.

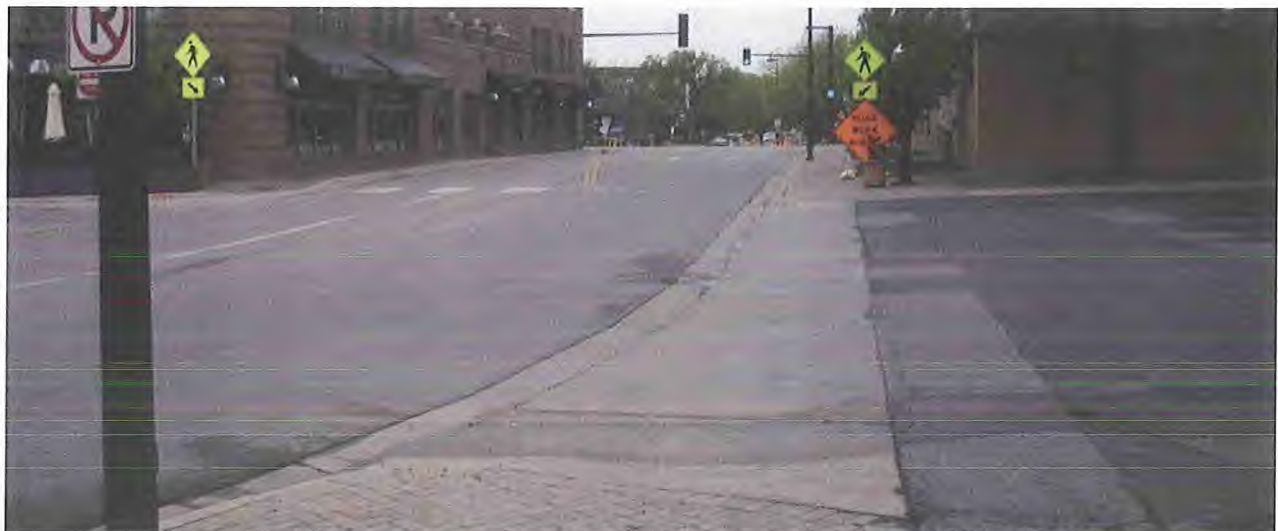
Photo : An unsigned, wide driveway in the 50th and France business district

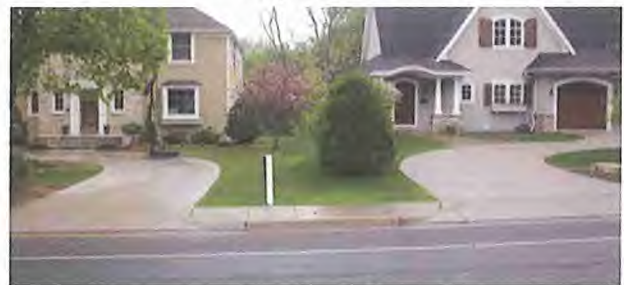
This request comes from a resident on Wooddale Avenue who has a driveway close to the neighbor's, and notes that vehicles park between the two. The end of radius of these driveways is 9 feet apart, with the edge of pavements being 16 feet apart behind the sidewalk. Edina Statue Ordinance Code 26-35(2) does not allow parking within 5 feet of any driveway. Using the larger measurement, there is 6 feet of space between the driveways available for parking, but a SmartForTwo™ is 8 feet long, and would be unable to fit into the space. Residents of both properties were supportive of a measure to deal with the issue. The adjoining neighbor seconded the request.

Photo : Straight curb between driveways

After review, staff recommends denial of this request. This decision was made considering that both of these properties have secondary access, and that yellow curb painting is rare in the city, and only used for specific circumstances.

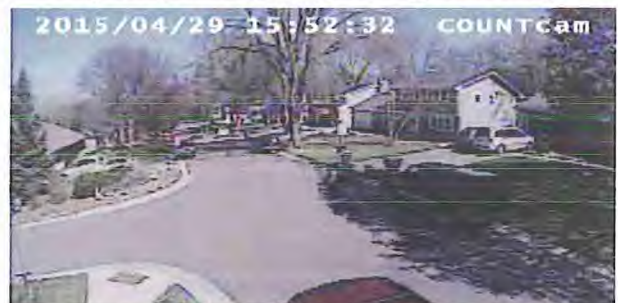
Photo: The video camera's view during school release.

turns or three-point-turns, where all children were crossing Nordic Circle. This action will be restricted with the new island being placed in this location (pending City Council approval). While in excess of twenty pedestrians crossed Creek Valley Road in this segment, no strong concentration of a specific crossing point was seen. Pedestrians and bicyclists also used all areas of the street and drivers were cautious, slowed down, and yielded right-of-way to the children during school release.

After review, staff recommends denial of this request. This decision is based on the small number of issues observed, the lack of concentration for crossings, a lack of sidewalks on the south side of the street, and standards for how to walk in the roadway indicating different crossing points for pedestrians walking in opposite directions. In addition, an island being painted and having flexible plastic posts will soon be tested in the area, and will mitigate some conflicts.

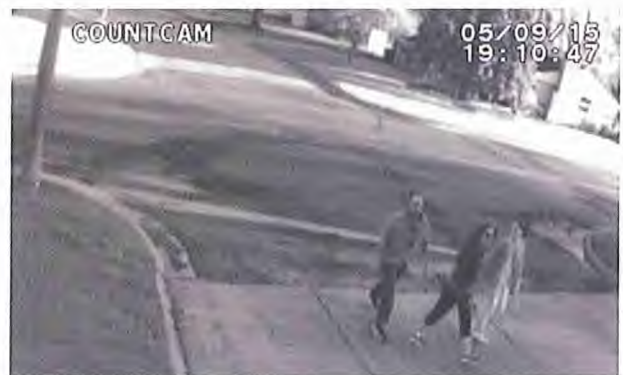
This request came from several neighbors in the Brookview Heights neighborhood, who noted that high speeds on 66th Street and the lack of pedestrian infrastructure made the area unwelcoming to pedestrians, and made getting to the park an unwanted experience. Video was gathered of the area on May 8th-May 10th of 2015 and was evaluated. A maximum of 15 people crossed in the maximum two-hour period, which does not meet warrants. The weather was mixed, with temperatures in the sixties, and rain on Sunday, May 10th. There are no sidewalks currently in the area, but one along 66th Street is planned. Crosswalk warrants are attached in Appendix A.

Photo: A group of pedestrians, as seen from the video camera

After review, staff recommends denial of this request due to not meeting crosswalk volume warrants. In discussion of further warrants, such as adjacent to public parks and having a high concentration of children, staff noted that Edina's crosswalk warrants are much looser than MnDOT recommends, and a lowering of the needed volume by one fourth is too much to be justified.

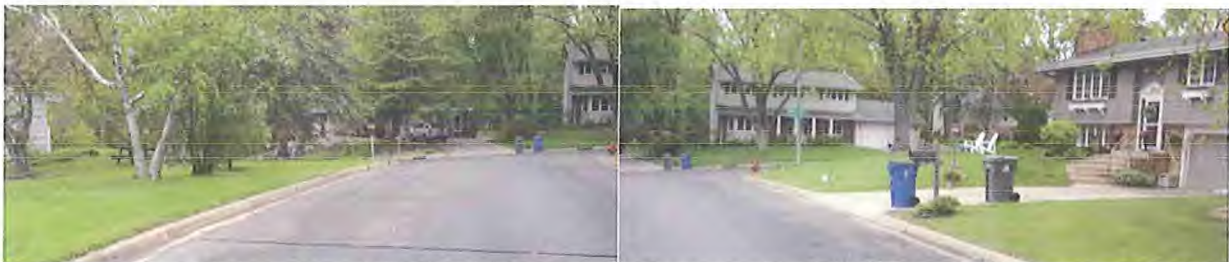
This request was forwarded from residents, by staff on the reconstruction of the Countyside H neighborhood this summer. This intersection was measured for sight-distance, with an uncontrolled intersection requiring 115 feet on each approach for 25 mph design speed (from the AASHTO "Green Book", A Policy on Geometric Design of Highways and Streets), and this intersection was found to not be able to meet those required safe sight-distances. This was due to significant grade changes and small setbacks blocking sight distances. In 2014 Grove Street south of the intersection had an ADT of 363 and an 85th-Percentile speed of 25.5 mph, a count was conducted on Grove Street, east of the intersection which had an ADT of 348 and an 85th-Percentile speed of 20.7 mph. Due to road conditions, Grove Street, east of the intersection was counted close to the intersection and the speeds were likely lower than further from the intersection.

Photos : Grove Drive, looking west towards the intersection, sight distance obstructions are shown here.

There have been no reported accidents, correctable by traffic control, in this location in the past 5 years.

After review, staff recommends denial of the request. With no history of accidents, it is unlikely that placing a stop sign would increase safety at this intersection. Additionally, the low speeds observed indicate that drivers are slowing as they approach the intersection, likely to gain proper sight distances.

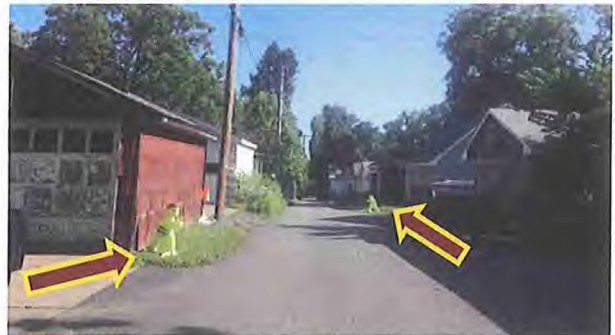
This request comes from a resident who has concerns that a recent alley paving project increased speeds in the alley, such that it is no longer safe for anything but use by vehicles. A traffic counter was placed in the alley and drivers were found to be in excess of the 10 mph speed limit slightly less than half the time, however, the 85th-percentile speed was 14.5 mph. The policy on alley speed bumps is attached in Appendix A. Another homeowner on the block expressed concern that the speed bumps were a ploy to gain control of the alley.

Photo: Neighbors are using small plastic men and flags in an attempt to slow drivers

After review, staff does not recommend placing the alley speed bumps. This is based off of low speeds in the alley as it currently exists. A cost estimate has been prepared and has been sent to residents should they wish to circulate a petition.

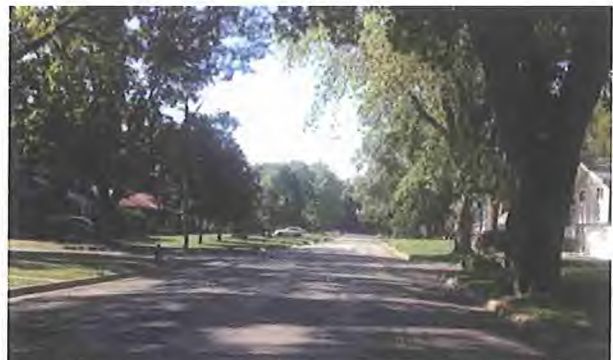
This request comes from a resident who is concerned that the intersection of 64th Street and Wilryan Road is dangerous, and that Wilryan Road has too much traffic in excess of the speed limit. A counter was placed and found that Wilryan had an ADT of 676 vehicles per day and 85th-percentile speeds of 29.4 mph. 64th Street was counted last year and has an ADT of 500 vehicles per day. No accidents in the last five years have been reported as related to the intersection.

Photo: Wilryan Avenue, looking south towards W. 65th Street

After review, staff recommends denial of this request. The 85th-Percentile of drivers' speeds was below the speed limit, and warrants for controlling the intersection were not met. Discussion of staff also determined that this route was likely receiving higher use than typical due to construction north of the area, but the data collected this year did not meet

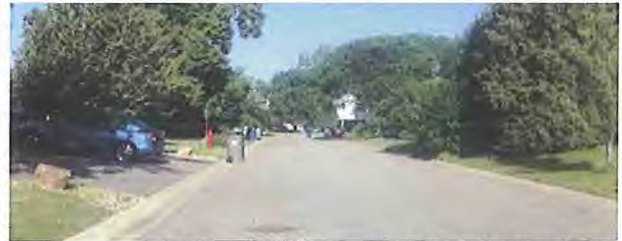
This request comes from a resident who is concerned with the volume of traffic circling the block of Cornelia Drive, Gloucester Road and 72nd Street looking for an access to Interstate 494. A counter was placed at the far southern end of the circular roadway, and it was found that fewer than 100 vehicles per day use the segment, and the 85th percentile speed is 22 mph. There have been no reported accidents due to this condition in the last five years.

Photo: Southern end of Cornelia/Gloucester

After review, staff recommends denial of this request. The low speeds and low volumes found indicate that this action of circling the block is infrequent, and likely is due to residents from nearby properties using the segment to access their property.

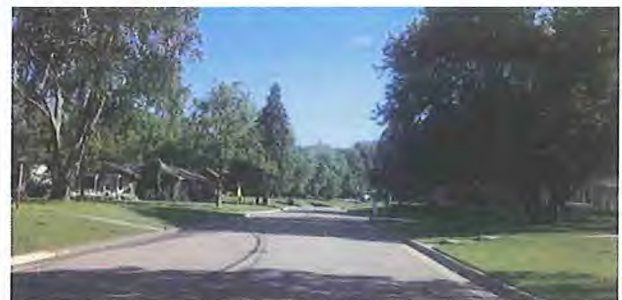
This request comes from a resident who is concerned with vehicle speeds on Code Avenue near Windsor Avenue. A counter was placed in this location, and the 85th-percentile speed was observed as 28.5 mph, and an ADT of 262 vehicles per day was also observed. There have been no reported accidents due to this condition in the last five years.

Photo: Code Avenue, looking north towards Windsor

After review, staff recommends denial of this request, based on 85th-percentile speeds below the speed limit. The area has been referred to the police department for placement of the speed trailer.

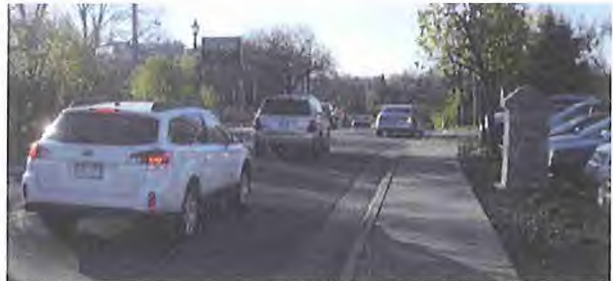
This issue was a C item on the November 05, 2014 report, and after further investigation, staff is prepared to make a recommendation on the issue. From the November 05 report; the requestor states that the Starbucks' drive-thru queue consistently is long enough for cars to be stopped on city streets, both Arcadia and Gus Young Lane. The requestor feels that this is an issue because the road is not wide enough for queued cars to be passed on their side of the centerline, and this leads to drivers crossing a double yellow line, violating expectations from drivers. In site visits queues were present in both directions, with both left-turning (northbound) and right-turning (southbound) queues appearing on their respective right hand sides of the roadway. In discussions with property management and Starbucks management, it was made clear that they were aware of the issue and had exhausted all their possibilities in dealing with the situation. Arcadia has 1186 ADT just north of this location, and Gus Young Lane has 4275 ADT in this location, with 85th-percentile speeds of 20 and 22 mph respectively. Arcadia in this location is 29.5 feet wide.

New information from a video study of the site shows that on the two days recorded, the morning rush (from 6:00 AM to 10:00 AM) had over 200 left hand turns, which caused most of the issues in the location. While only fifteen times over the two day period did the back-up from the Starbucks cause delays, block, or otherwise impede other traffic. Fourteen of the fifteen issues observed occurred within the hours of 7:30 AM and 9:30 AM, while 107 drivers turned left into the parking lot and drive through during this time. Delays may have lasted a few minutes as drivers waited for a space in the drive-thru line and included delays behind vehicles, as well as delays from the roadway acting as a single lane roadway for a short distance between the two queues out of the parking lot.

Photo : Arcadia, looking south

After review, staff recommends no action on this item, as even at the highest concentrations of issues, less than ten percent of drivers caused delays to others. Additional reasons for denial include safety concerns being minimal, and inconvenience being seen as the main factor in the requests, as well as the redevelopment planning and
